SERVICE LETTER

Service Letter Number	Simplex Model	Description of Revision	Revision	Revision Date
SI2012-005 rev.B	508	Revised quantity of fasteners given the substitution allowances. Combined figures 2 and 3	B	September 10th, 2012

Subject: Replacement of fasteners in Turret Assembly.

Applicability: This service letter is applicable to Simplex Manufacturing Model 508 P/N 508-302102-501

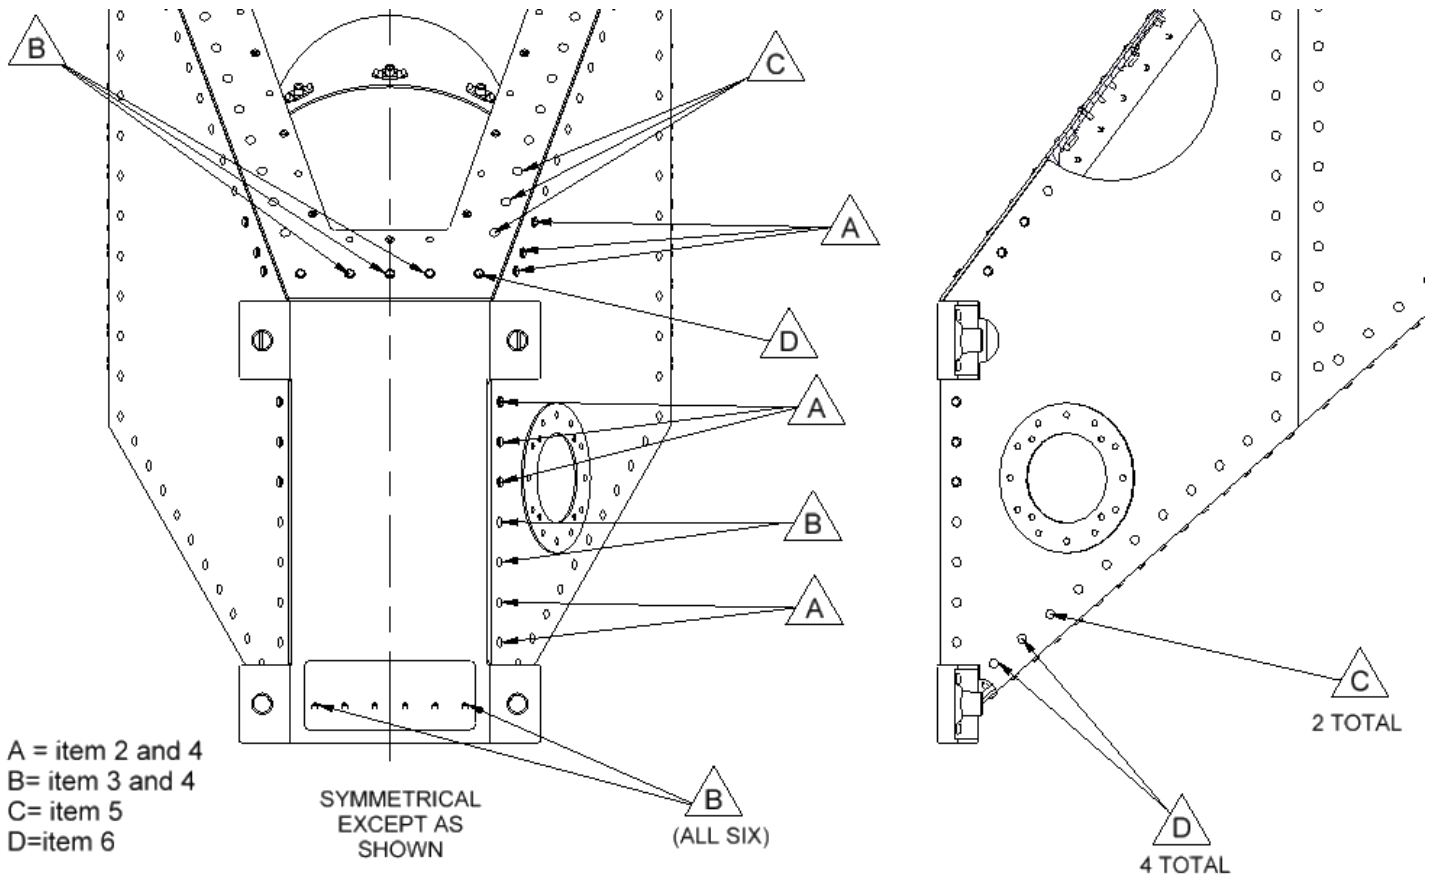
Figure 2 Fastener replacement

Purpose: Operators have reported instances of fastener movement and loosening in portions of the Turret box. This service letter provides the instructions for replacement of fasteners in the Model 508 Turret.

1. Permissible to remove Turret from Box beam Assembly to facilitate fastener replacement.
2. Drill out and discard fasteners shown in fig. 2. Note edge margins prior to removing fasteners shown in fig. 2.
3. Using existing locations, install fasteners IAW fig. 2. HL18-5-x locations require #20 diam drill. CR3213-5-x rivets require #21 drill bit. Deburr holes and brush Alodine and chromate primer affected metal.
4. Touch up fastener heads to match surrounding structure.
5. Re-Assembly turret onto main box beam

REMOVE AND REPLACE FASTENERS AS SHOWN.
ACCEPTABLE TO USE ITEM 5 OR 6 WHERE EDGE
MARGIN OF 1.5D IS UNATTAINABLE FOR ITEM 2 OR 3 HI-LOCK
