SERVICE LETTER

Service Letter Number	Simplex Model	Description of Revision	Revision	Revision Date
SI2012-005 rev.B	508	Revised quantity of fasteners given the substitution allowances. Combined figures 2 and 3	B	September 10th, 2012

Subject: Replacement of fasteners in Turret Assembly.

Applicability: This service letter is applicable to Simplex Manufacturing Model 508 P/N 508-302102-501

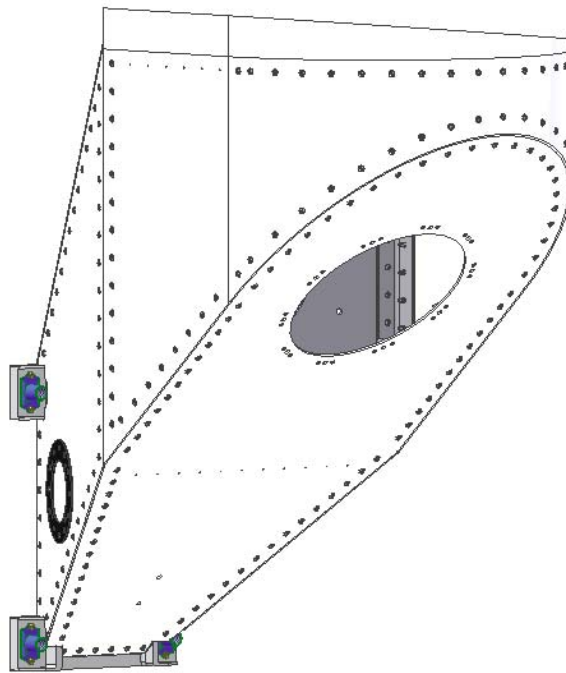
**Figure 1 Turret Assembly**

Purpose: Operators have reported instances of fastener movement and loosening in portions of the Turret box. This service letter provides the instructions for replacement of fasteners in the Model 508 Turret.

1. Permissible to remove Turret from Box beam Assembly to facilitate fastener replacement.
2. Drill out and discard fasteners shown in fig. 2. Note edge margins prior to removing fasteners shown in fig. 2.
3. Using existing locations, install fasteners IAW fig. 2. HL18-5-x locations require #20 diam drill. CR3213-5-x rivets require #21 drill bit. Deburr holes and brush Alodine and chromate primer affected metal.
4. Touch up fastener heads to match surrounding structure.
5. Re-Assembly turret onto main box beam
