SERVICE LETTER

HOVER PUMP BUMPER REPLACEMENT

ON THE SIMPLEX MODEL 301 HOVER PUMP

Document No.: SL2010-004
Date: March 23, 2010
Used On: Simplex Model 301

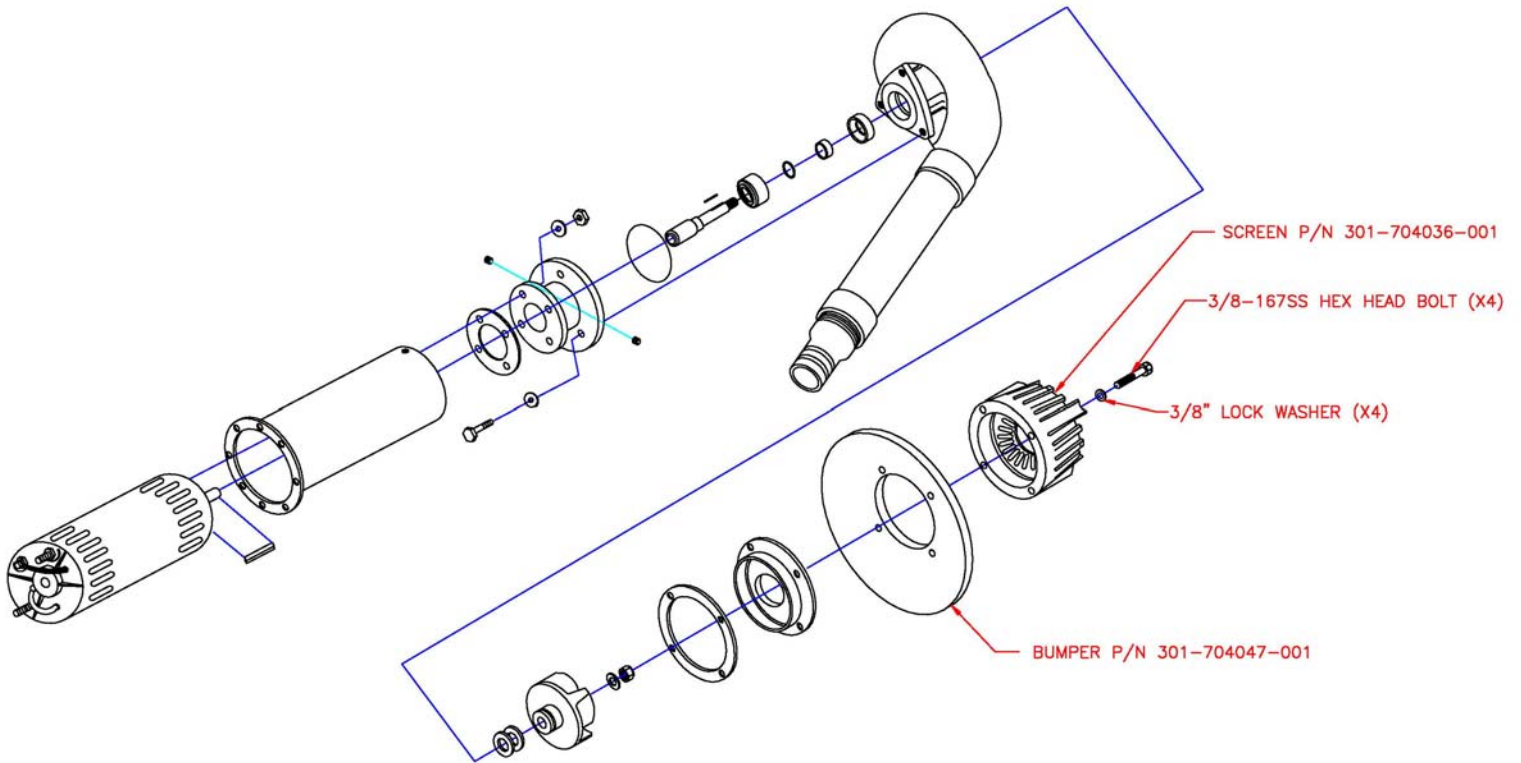
Step	Description
1	Remove four (4) 3/8" bolts and lock washers from bottom screen. See Figure 1-1. Retain hardware for re-installation
2	Remove screen P/N 301-704036-001. See Figure 1-1
3	Removed damaged bumper.
4	Re-install new bumper and screen using hardware retained from step 1.
5	Replacement is completed.
